Attachments to Appendix B

Attachment B-1

Photographic Documentation of Site Reconnaissance (2-6 March 1998)

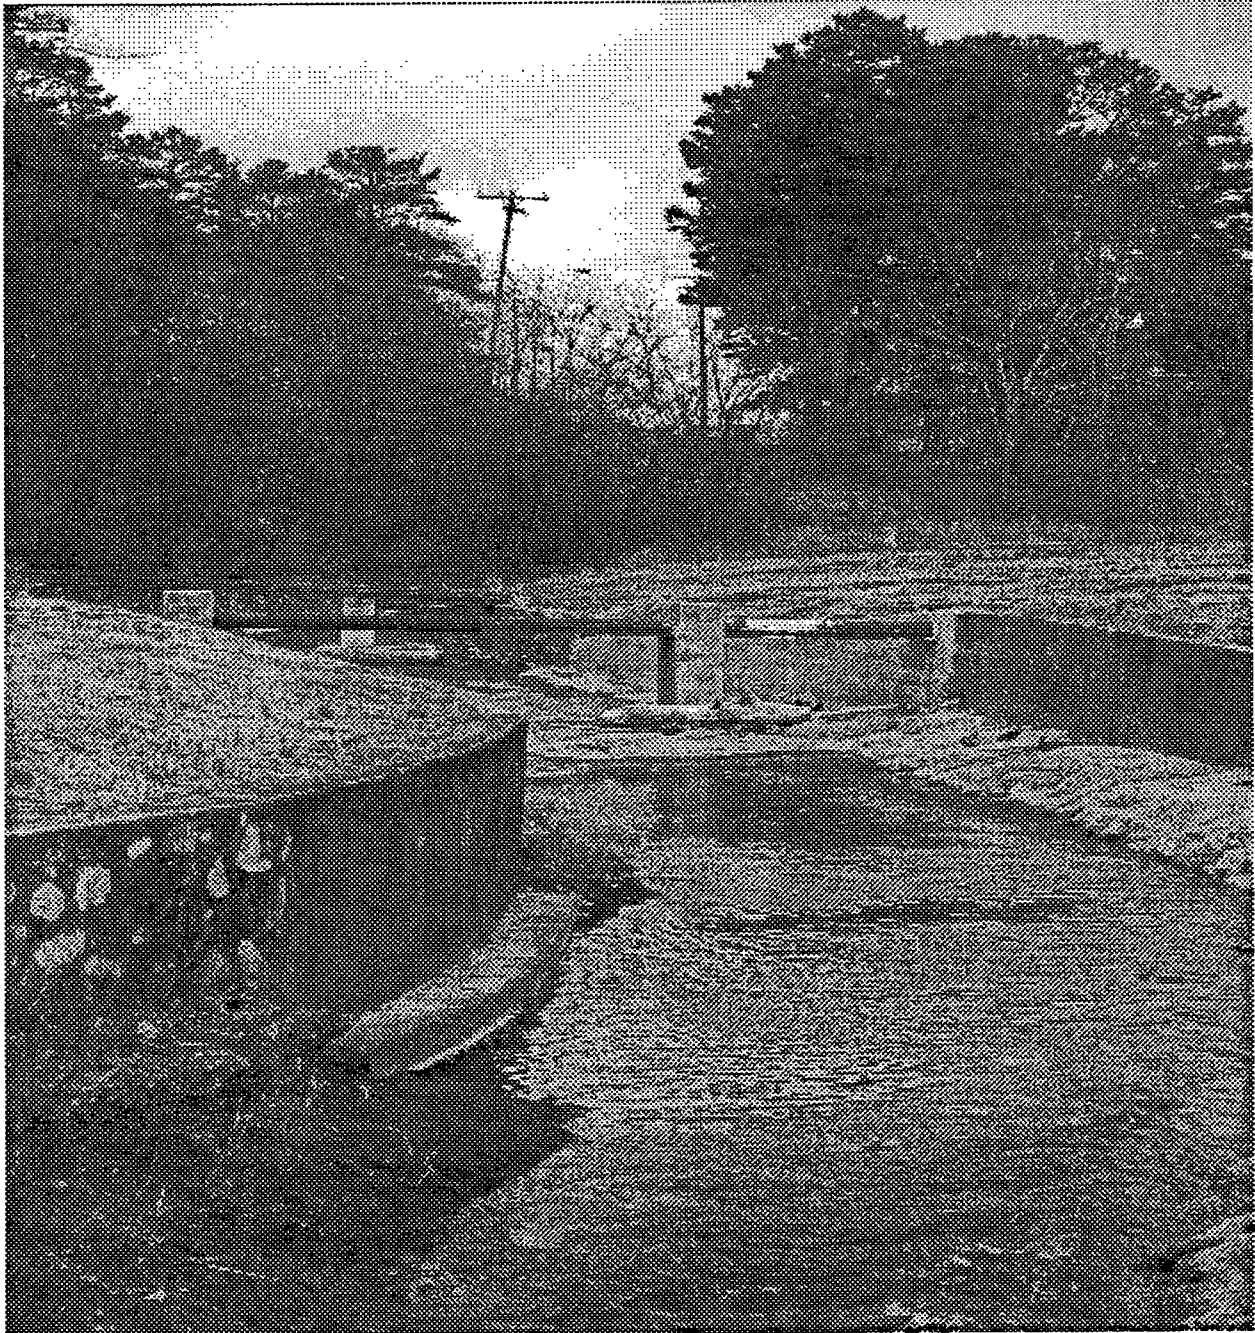
Photo A1 [3/3/98 - 9:34]

General Service Administration (GSA) Area and surrounding warehouses [CERFA Parcel Map: 15,34].
NW of Site 129(7) and E of Site 60(7): photo faces NW (in direction of McClellan Blvd [Hwy 21]).

The view of Cane creek shows it to be highly channelized and augmented by walls and concrete. The terrestrial habitat surrounding this reach of the creek is moderately to highly developed (to the E and SE of photo location) open lawn areas, fences, and buildings. Stands of trees exist among developed areas, and along portions of the creek.

Foreground (left) of photo shows some soil erosion and vegetation. Location of Photo A2 is on left bank of creek directly in center of this photo.

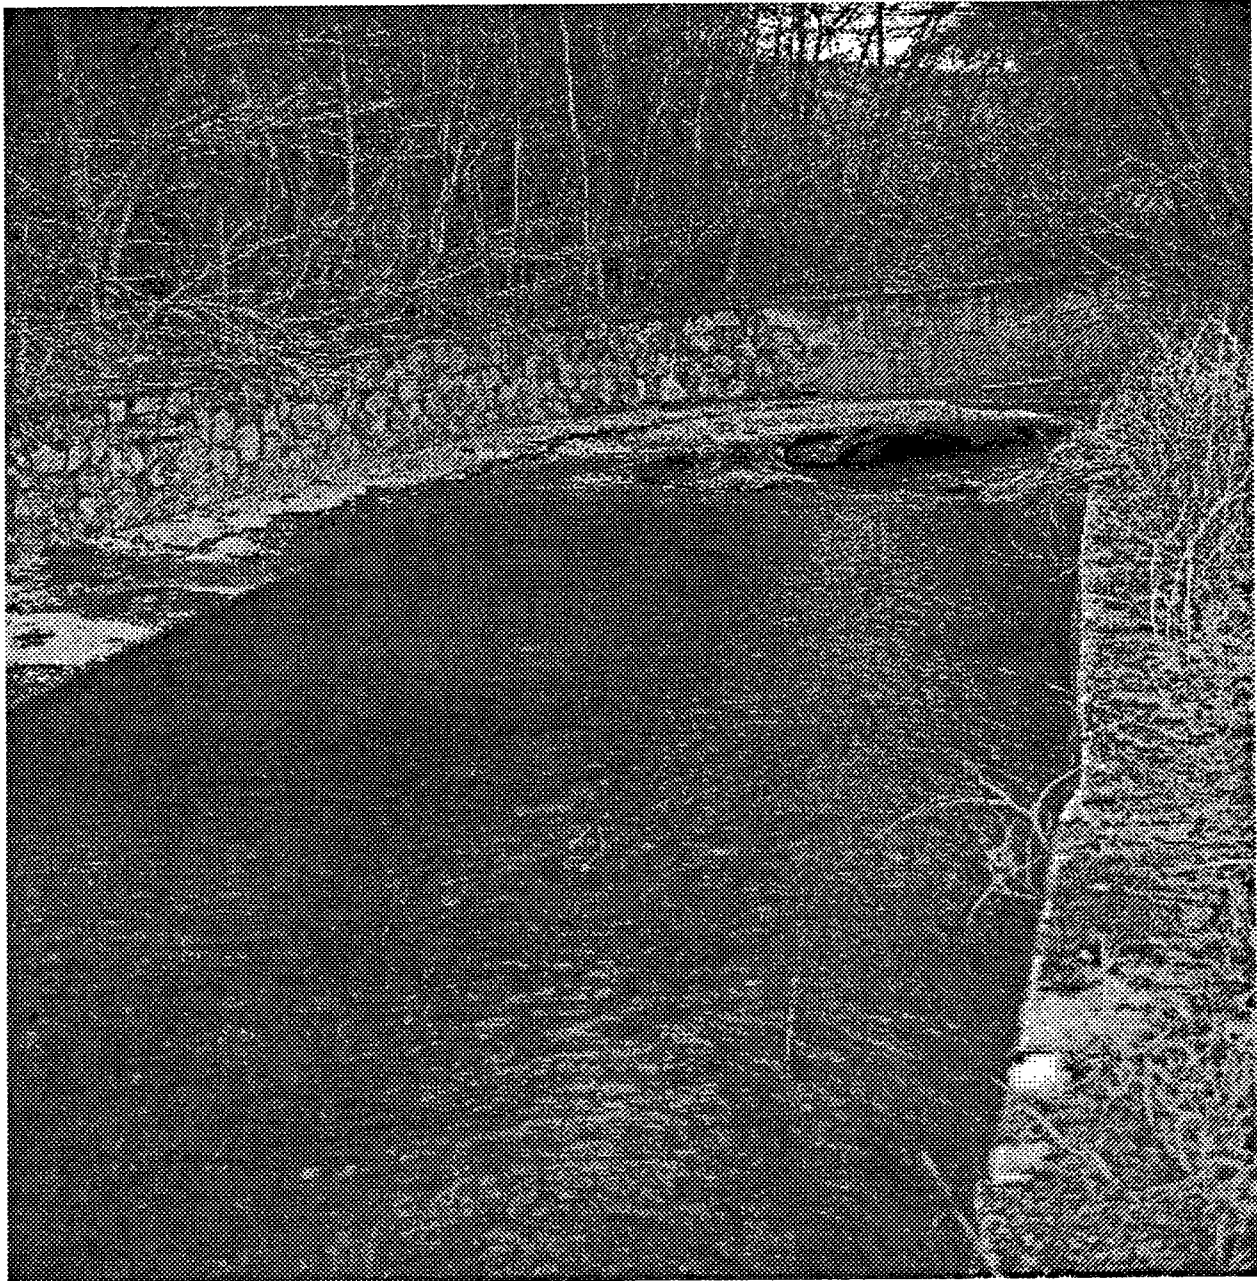
Photo A2 [3/3/98 - 9:40]

General Service Administration (GSA) Area and surrounding warehouses [CERFA Parcel Map: 15,34]. NW of Site 129(7) and E of Site 60(7): photo faces NW (in direction of McClellan Blvd [Hwy 21]); approximately 50 yards downstream of Photo A1.

The view of Cane Creek shows it to be highly channelized and augmented by walls and concrete. The aquatic habitat is not natural. Substrate within this reach of the creek is characterized by patchy sediments consisting of gravel, sand, and some fines. A major fraction of the substrate is bedrock and some concrete. Flow is fairly rapid (i.e., not conducive to much deposition).

This reach of Cane Creek contains a large patch of aquatic vegetation growing within the central portion of the creek, adjacent to concrete substrate. Several small (~1 foot high) weirs or cascades have been graded into the creek bed at irregular intervals.

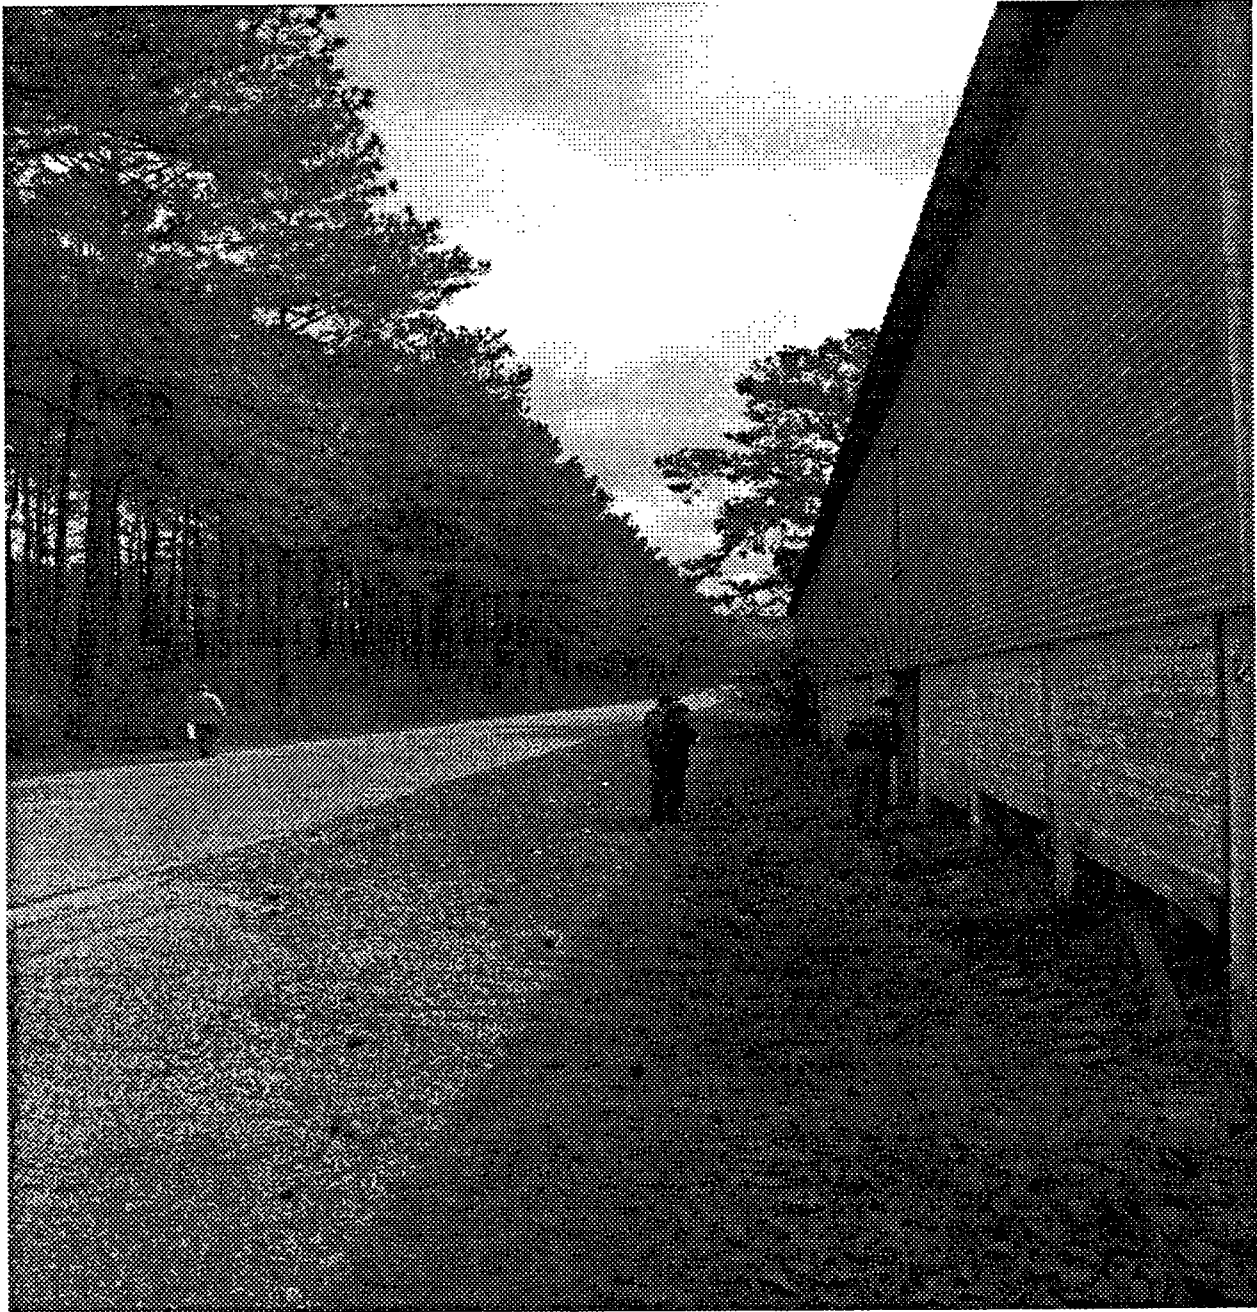
Photo A3 [3/3/98 - 9:55]

General Service Administration (GSA) Area and surrounding warehouses [CERFA Parcel Map: 16,34]. Site 151(7), on road between old building (#257) and Cane Creek: photo faces SW direction with Building 257 on the right and road parallel to Cane Creek on left.

The site (building 257) is approximately 40-50 yards SW of Cane Creek. Drainage ditches run adjacent to the building, parallel to the road and creek. Drainage pipes run under the road and discharge to a 20-30 yard wide strip of moderately vegetated land immediately adjacent to Cane Creek. Drainage pathways to the creek are not obvious. Indications of solids deposition and stormwater evaporation are evident immediately below some of the discharge pipes.

This reach of Cane Creek is channelized and augmented by stone/concrete walls. Substrate is partially covered by concrete; natural substrate is gravel sand with pockets of fine sediments.

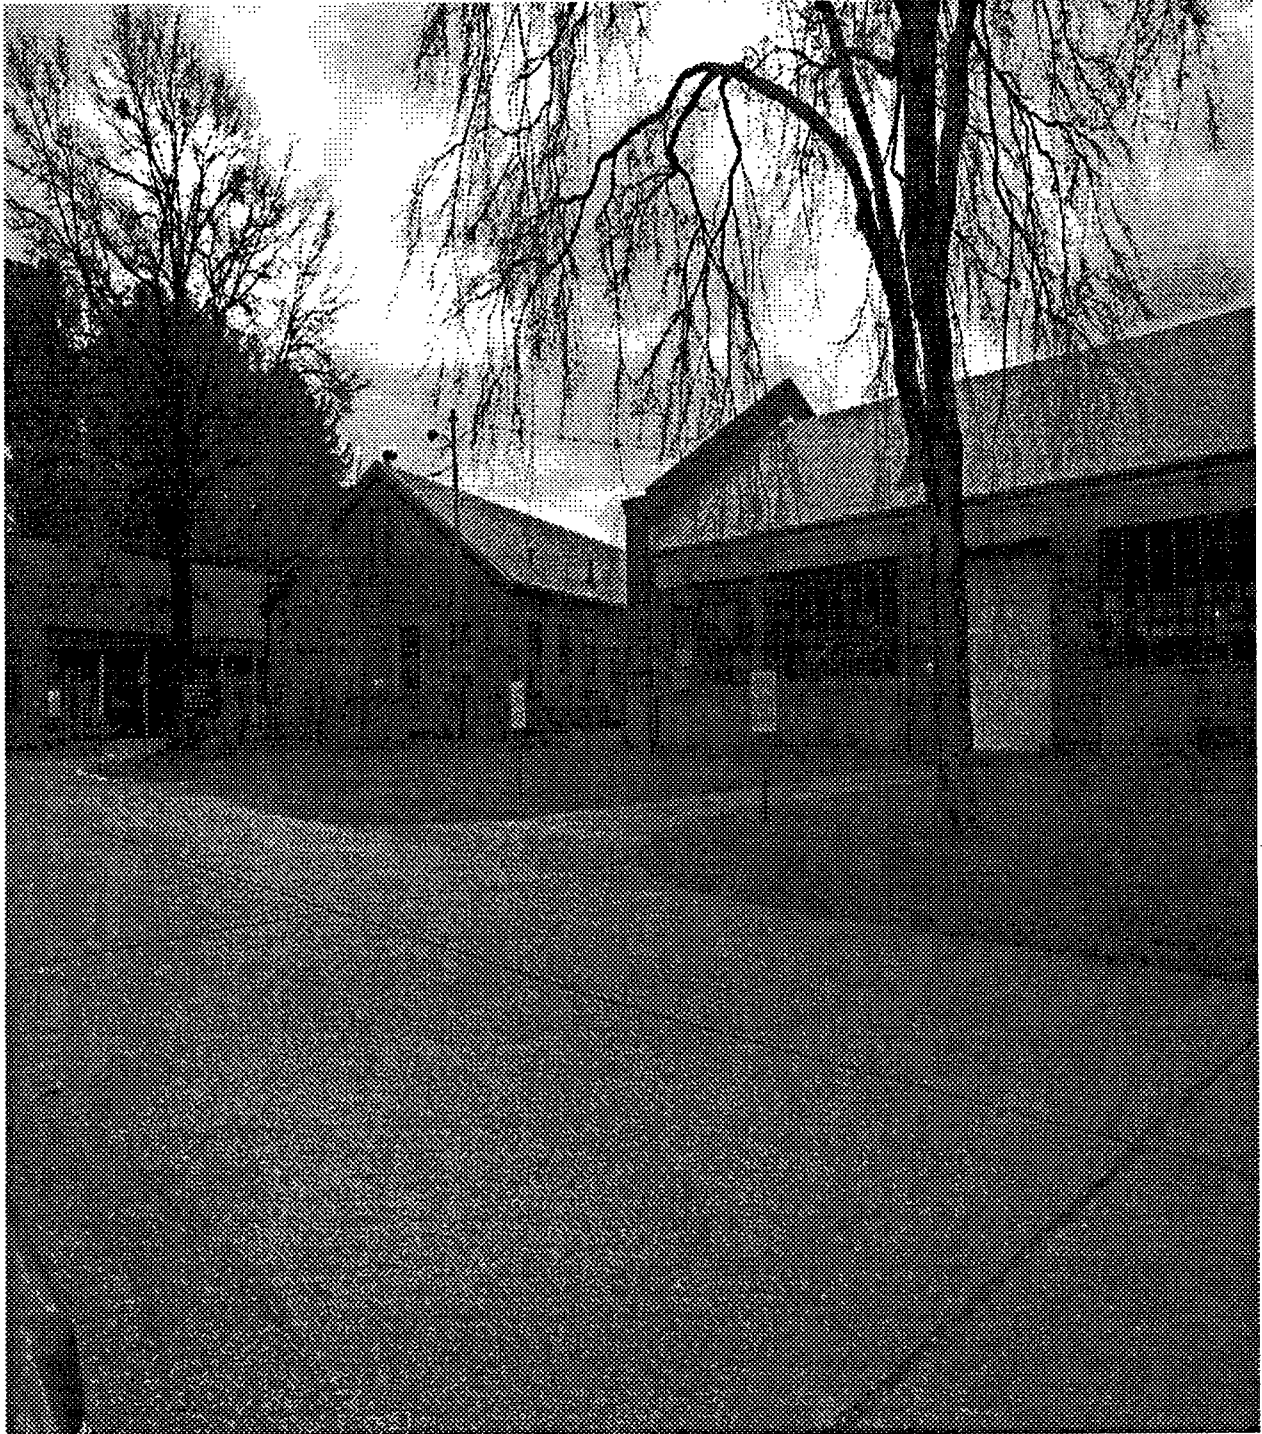
Photo A4 [3/3/98 - 10:12]

General Service Administration (GSA) Area and surrounding warehouses [CERFA Parcel Map: 17,33].
In the parking-lot N of Site 67(7): photo faces S (looking onto motor pool building area).

This area comprises the heart of the GSA area. It is a building within a cluster of buildings and pavement. Very small areas of maintained lawn and single trees are interspersed within the complex. This area and associated sites represent very poor habitat for terrestrial or aquatic receptors. Exceptions might be a limited population of terrestrial invertebrates, a limited population of small mammals (e.g., mice and rats) and small omnivorous birds (e.g., robins).

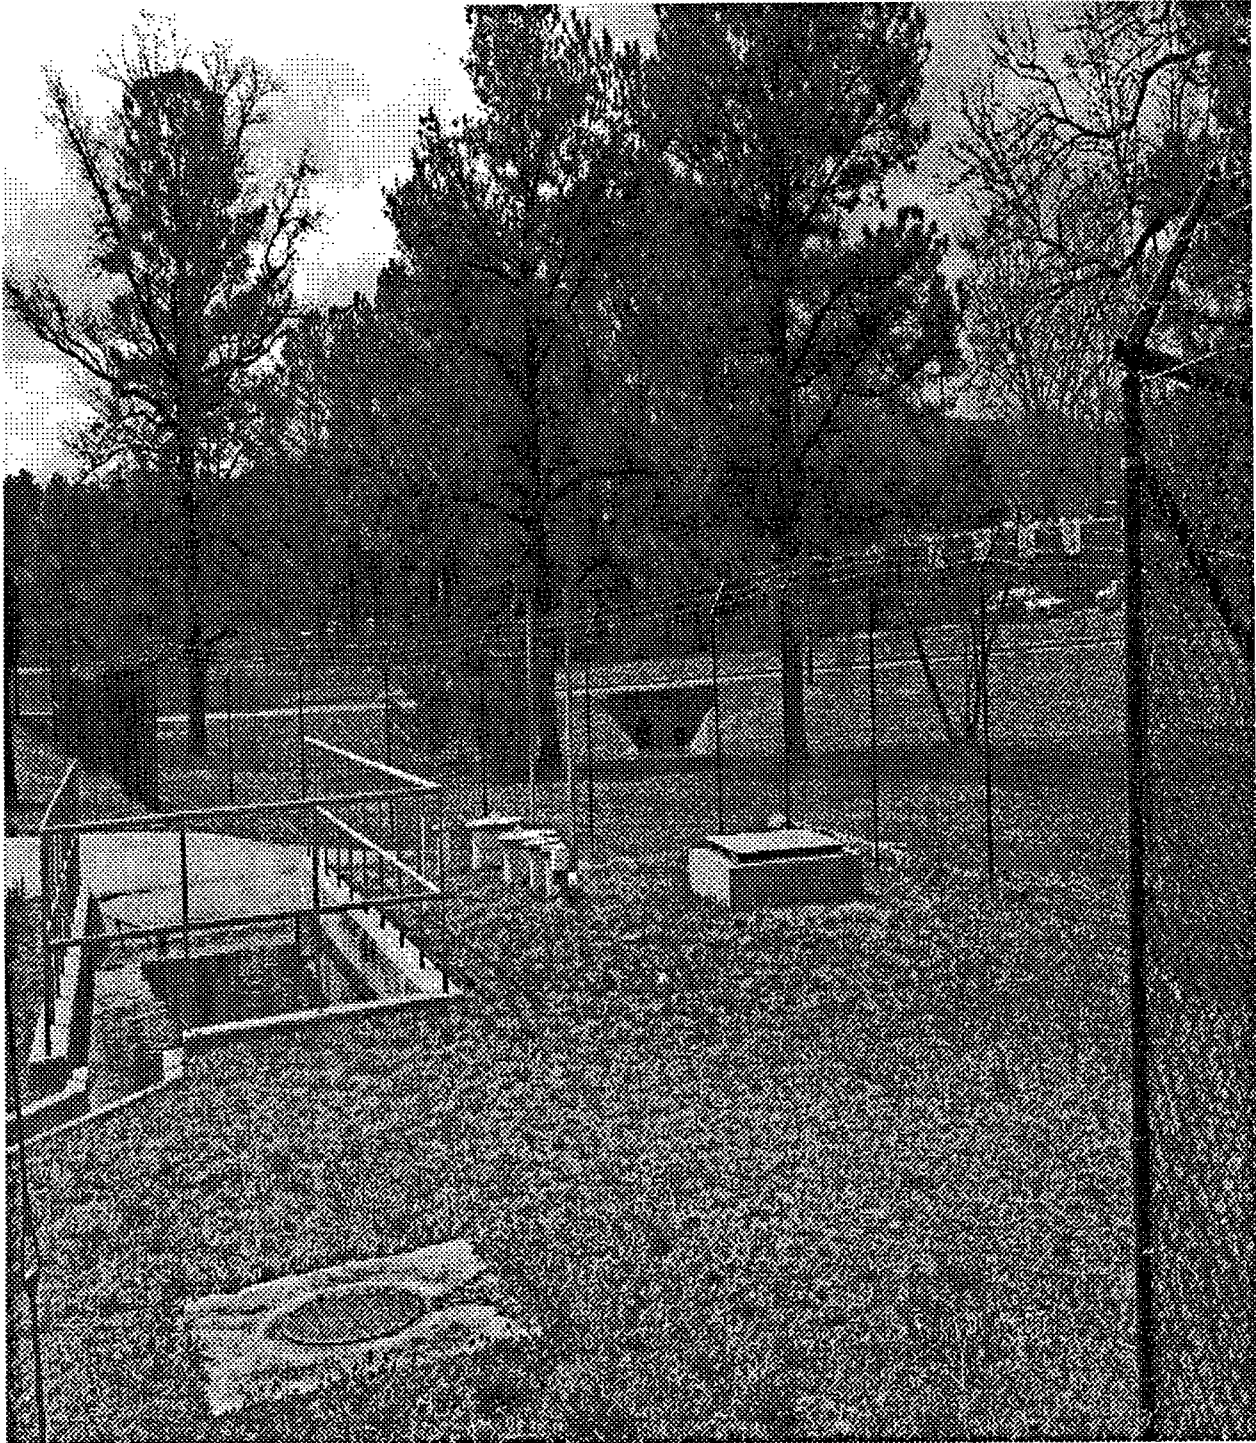
Photo A5 [3/3/98 - 10:23]

General Service Administration (GSA) Area and surrounding warehouses [CERFA Parcel Map: 17,33].

In the GSA complex near Sites 69(7) (in photo; left), 91(7) (just out of photo view; left), and 2(7) (opposite photo view; behind viewer); photo faces SW from GSA/Motor Pool lot.

The view looks directly at stormwater pipes under road. They divert storm water to South Branch Creek. Small areas of maintained lawn and single trees are interspersed within the complex. This area and associated sites represent very poor habitat for terrestrial or aquatic receptors. Exceptions might be a limited population of terrestrial invertebrates, a limited population of small mammals (e.g., mice and rats) and small omnivorous birds (e.g., robins).

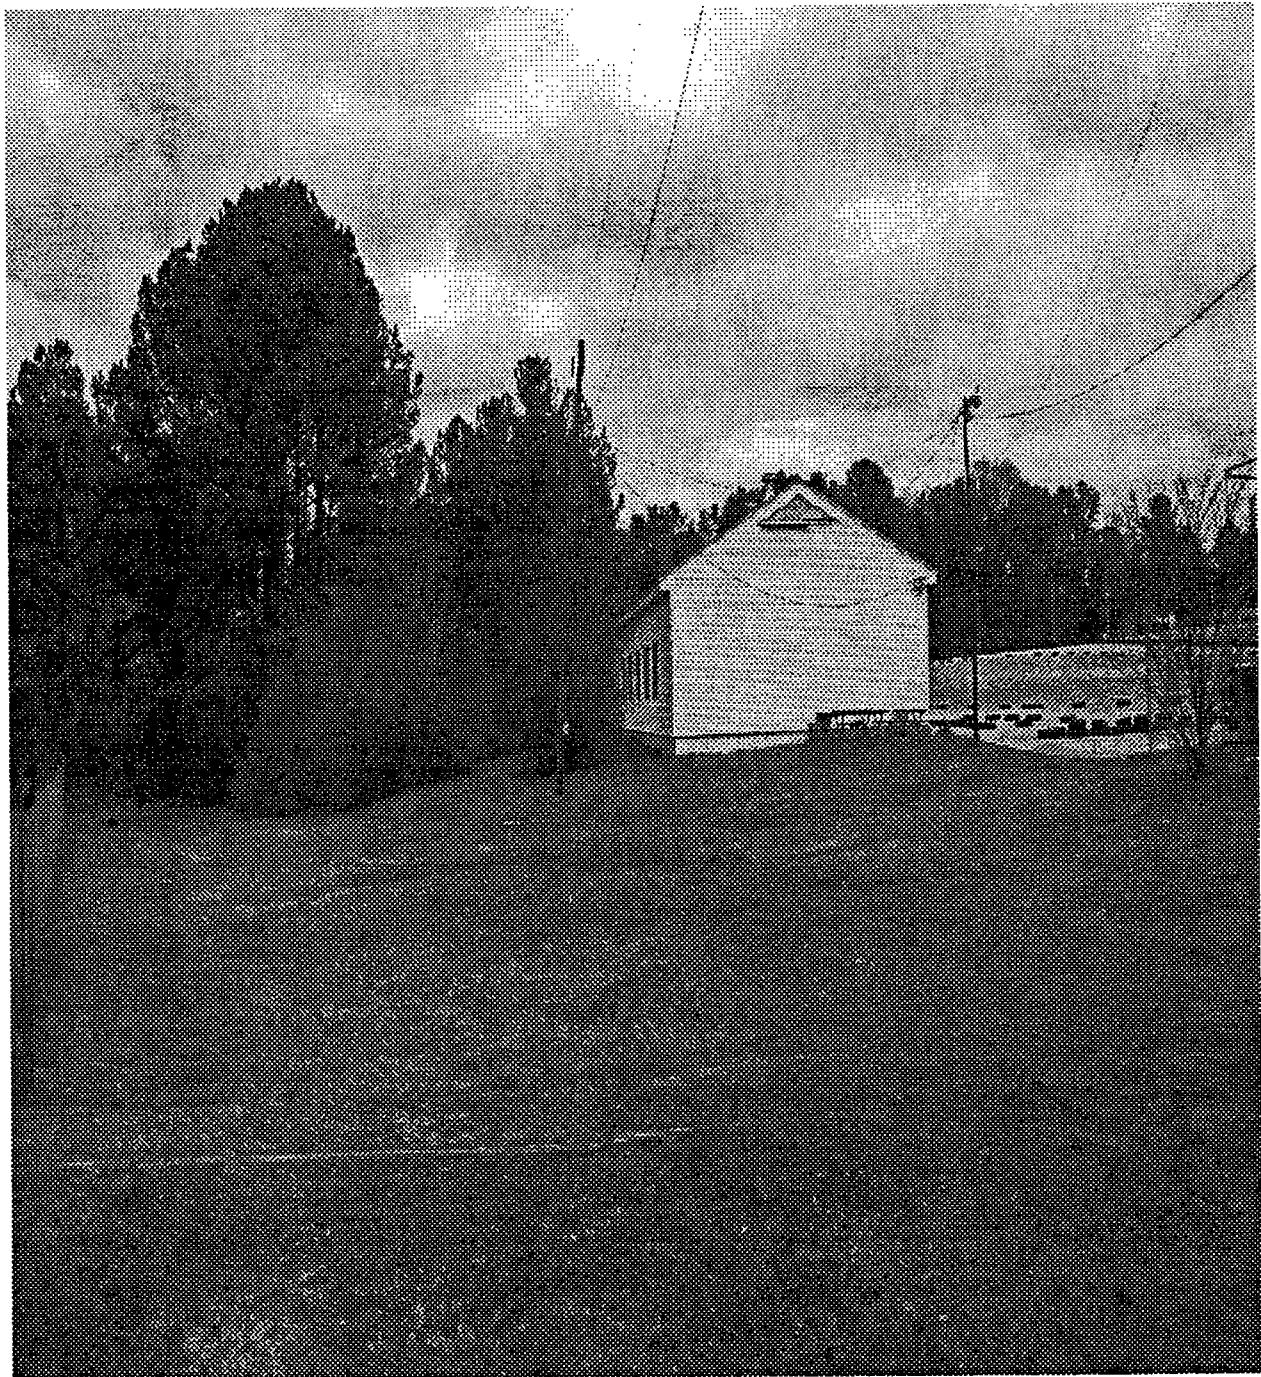
Photo A6 [3/3/98 - 10:43]

Former Motor Pool 2000 and Former gas station [CERFA Parcel Map: 18,31-32]

General site 144(7) was located on and behind the area currently occupied by a go-cart track and associated building (in photo); photo faces NW direction.

The Former Motor Pool 2000 site is adjacent to an area of heavy vegetation and stands of pine trees. A drainage ditch runs along the WSW edge of the go-cart site and discharges to South Branch Creek. A second drainage path (see Photo A7) runs from the SSE corner of the paved area in a WSW direction and apparently discharges to South Branch Creek. The second site (137(7)) is associated with a former gasoline station. Its suspected location (not photographed) is currently covered by pavement, and is adjacent to a major street and heavy commercial development.

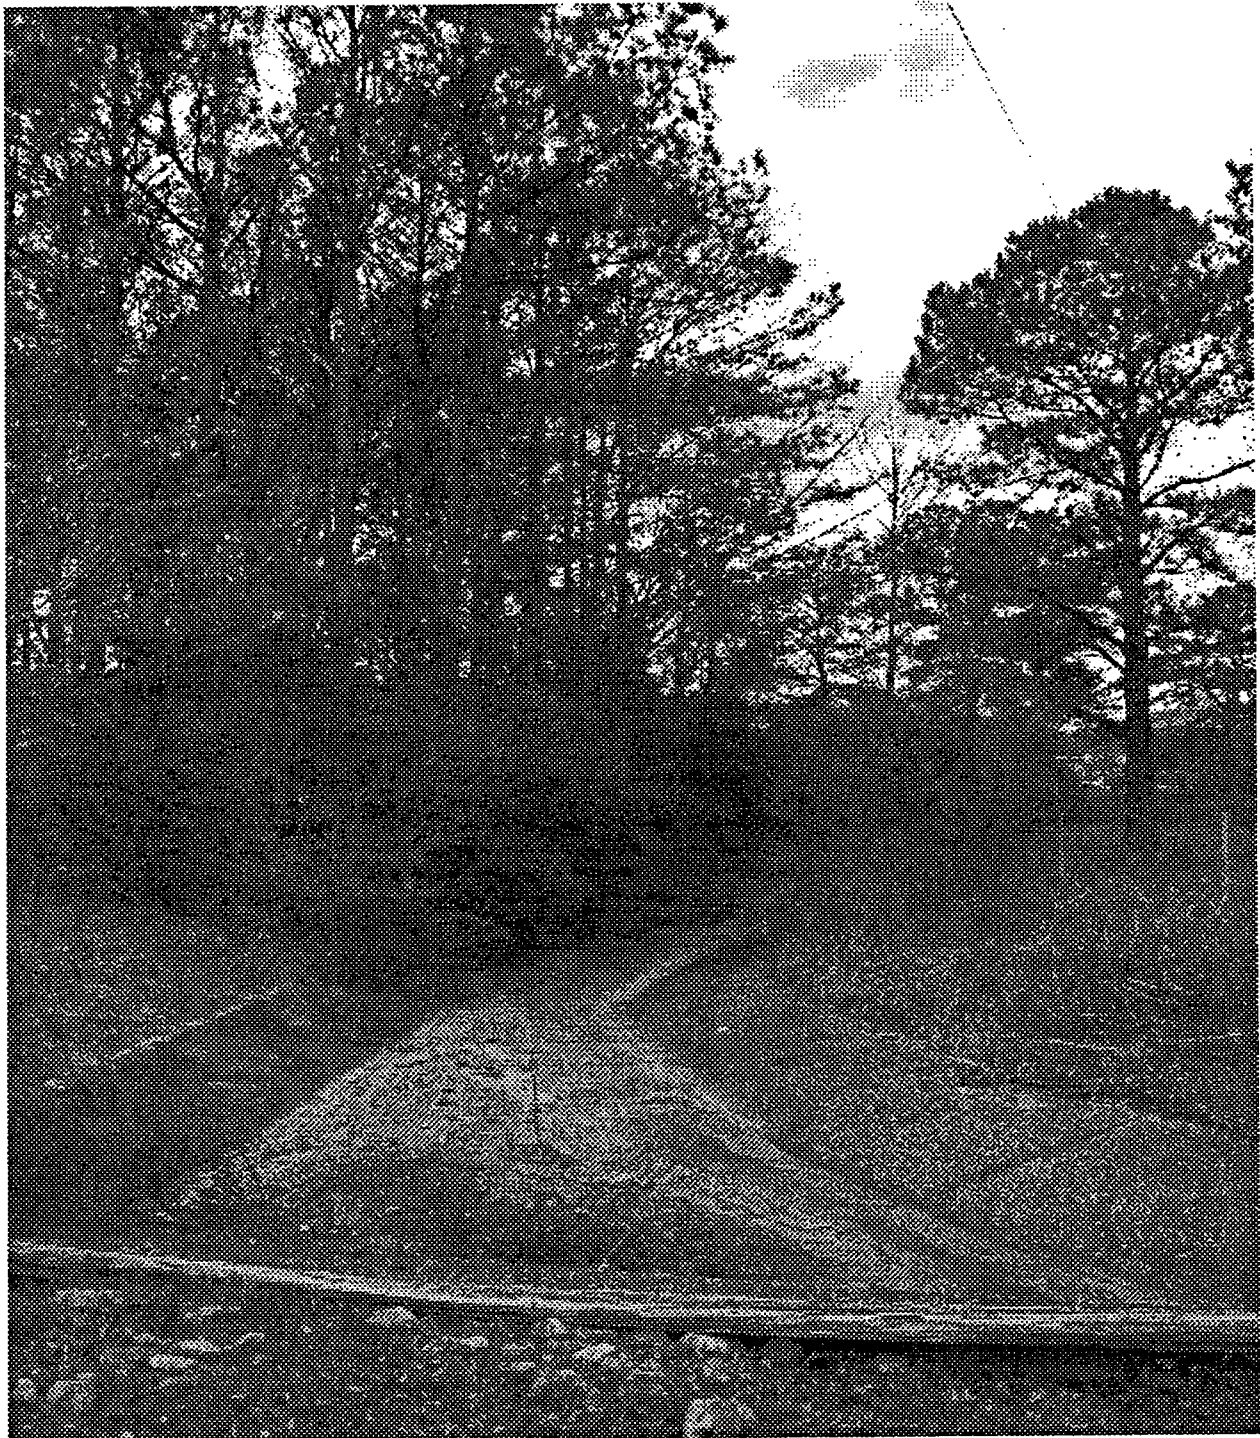
Photo A7 [3/3/98 - 10:43]

Former Motor Pool 2000 and Former gas station [CERFA Parcel Map: 18,31-32]

General site 144(7) was located on and west of the area currently occupied by a go-cart track and associated building, photo faces WSW direction, looking down a drainage ditch draining storm water runoff into South Branch.

Area immediately adjacent west of Site 144(7) is occupied by a training area with obstacle-course type equipment surrounded by heavy vegetation and stands of trees. Area surrounding the tree stands is fairly heavily developed (e.g., streets, buildings, paved lots, etc.).

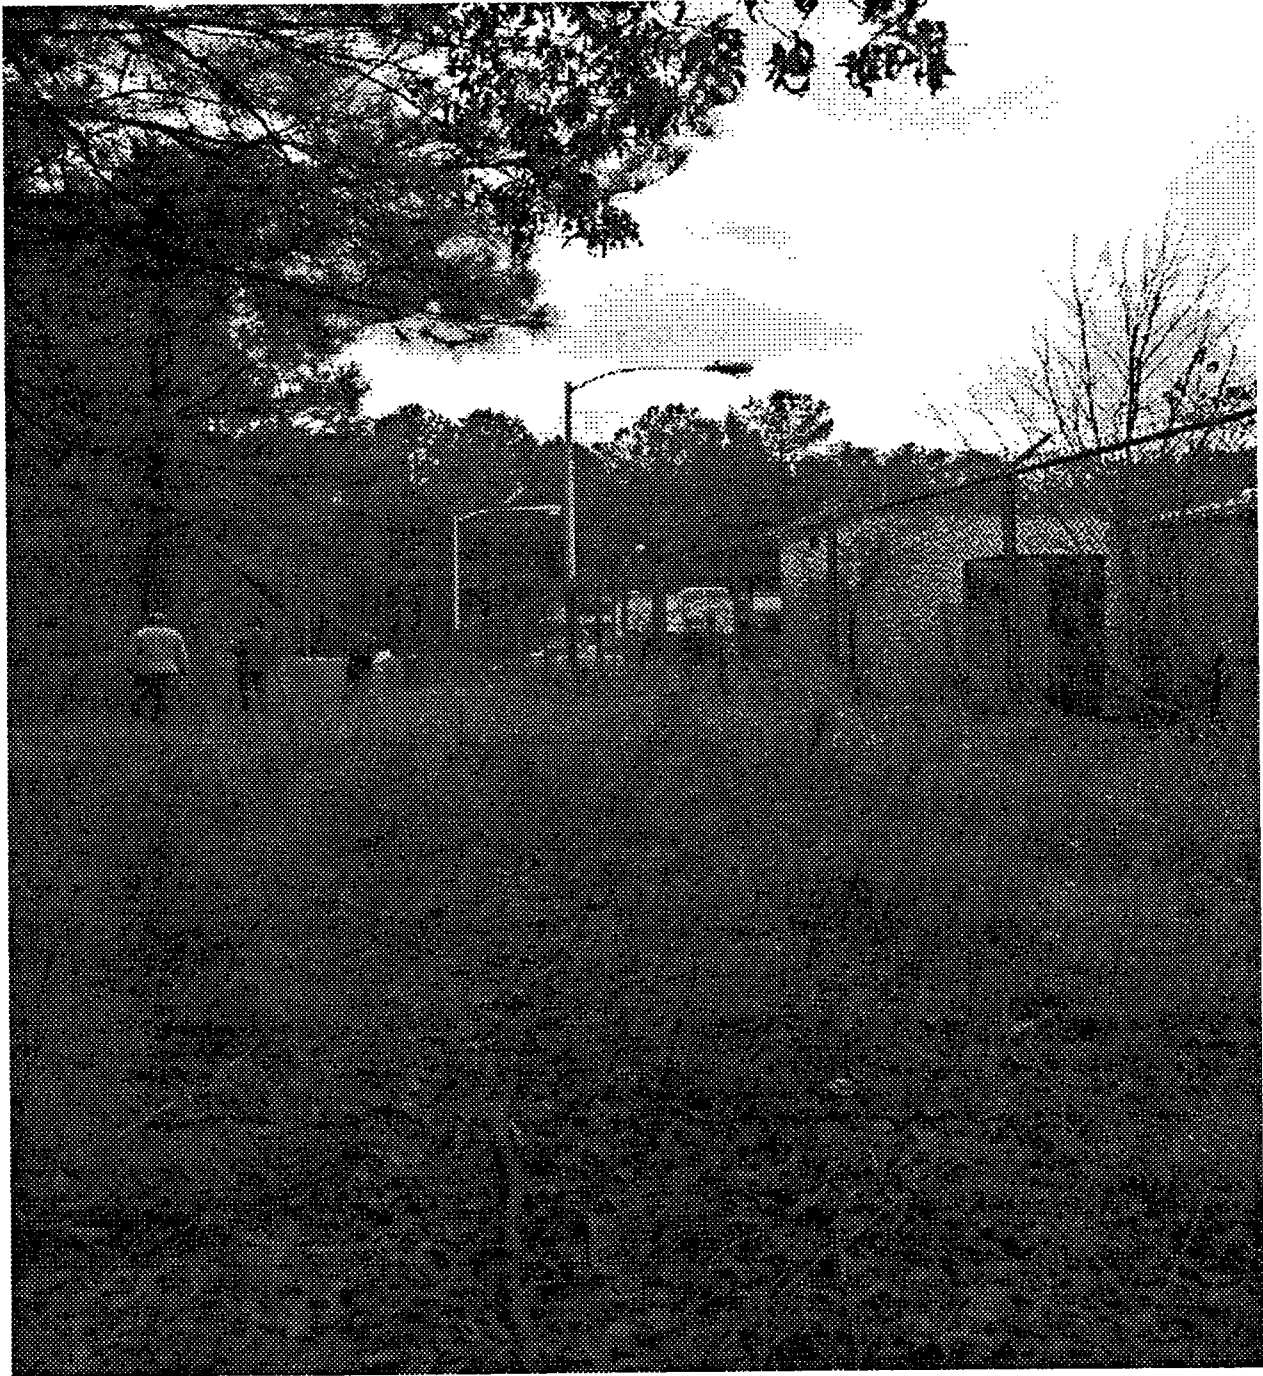
Photo A8 [3/3/98 - 10:55]

Former DPDO Area Building 1800 and current Autocraft Area

Area contains sites 100(7), 20(7), and 47(7), and is nestled between the fork of South Branch Creek and an unnamed tributary to same; photo faces SSW direction, along the SE fenceline toward road separating the Autocraft Area from the Sandel Flame Range (See Photo A16).

The view shows the SE fenceline separating the fenced area (containing buildings, oil/water separator, etc.) from a lightly forested area (deciduous trees with very little under brush (see Photo A9). Approximately 100 yards to the left of view is South Branch Creek. White building in view is near site 47(7).

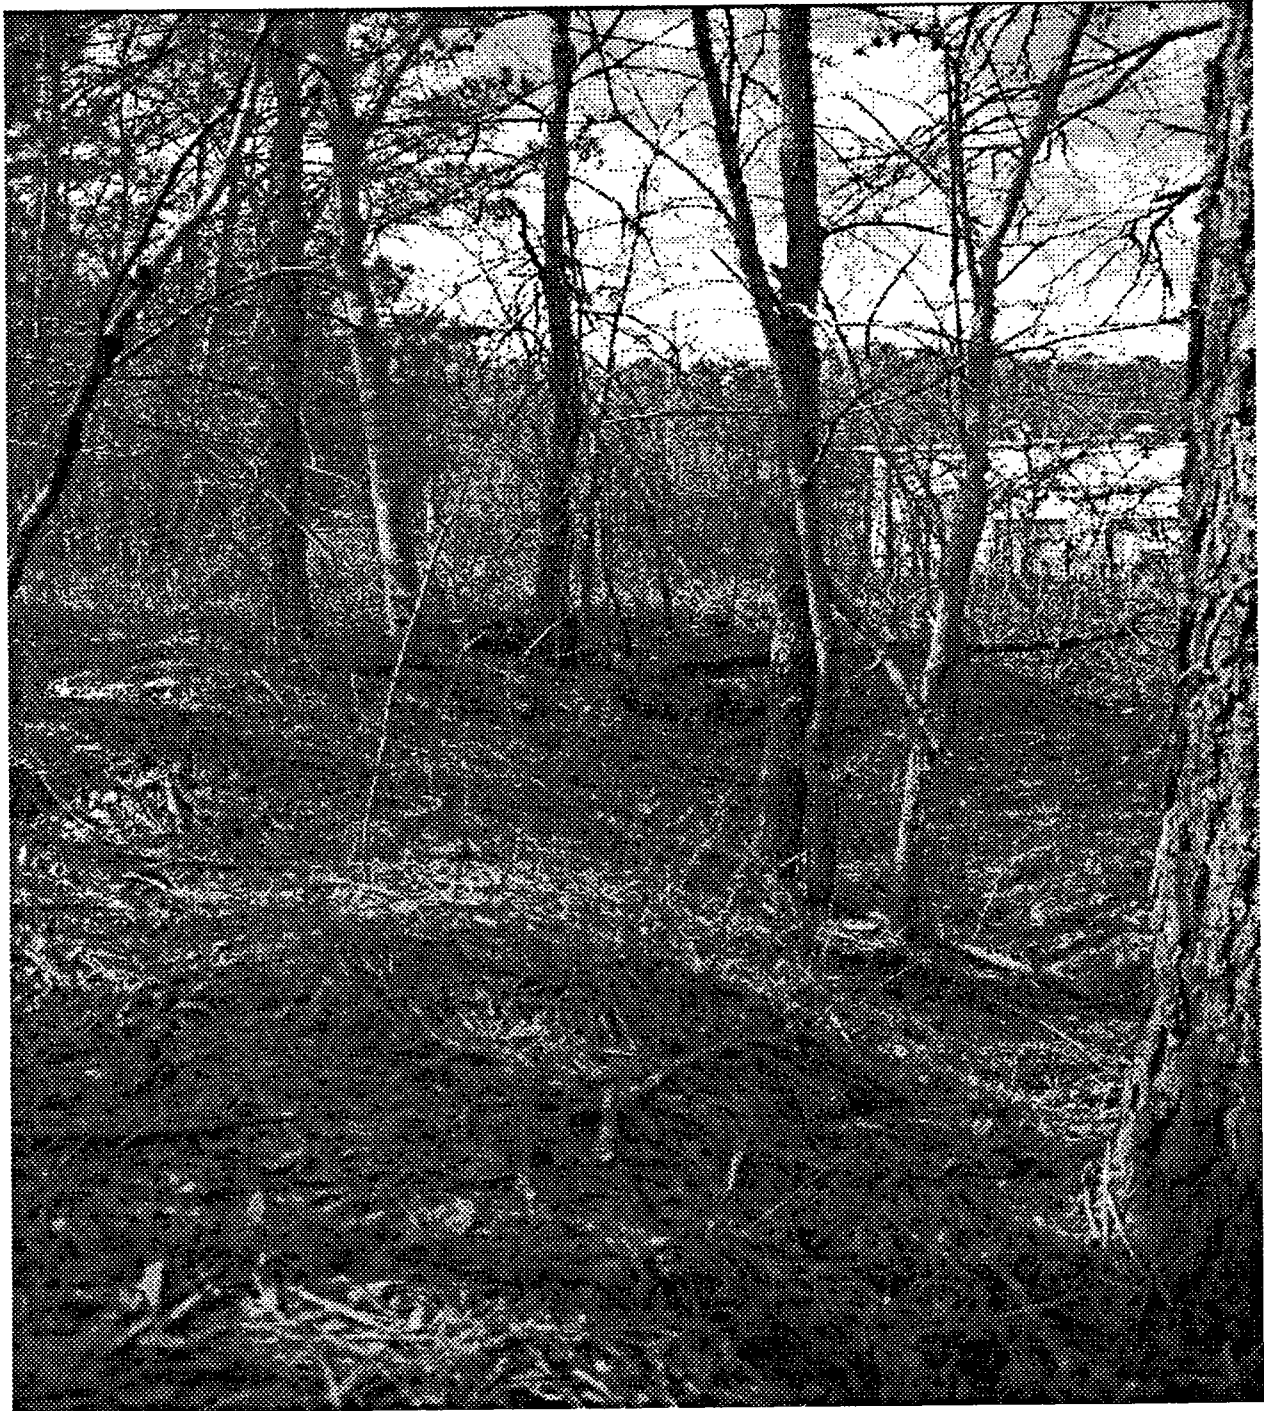
Photo A9 [3/3/98 - 11:00]

Former DPDO Area Building 1800 and current Autocraft Area [CERFA Parcel Map: 18,28-29]

Area contains sites 100(7), 20(7), and 47(7), and is nestled between the fork of South Branch Creek and an unnamed tributary to same; photo faces WNW direction, view of the SE fenceline with a drainage ditch/pipe outfall in the shadowy background (under the base of the fallen tree).

The drainage ditch in view carries stormwater flow toward viewer and discharges water either to South Branch Creek (behind viewer) or deposits water onto shallow flat between discharge pipe(s) and creek. This view also shows the general vegetation and tree density of the immediate area adjacent to the Site.

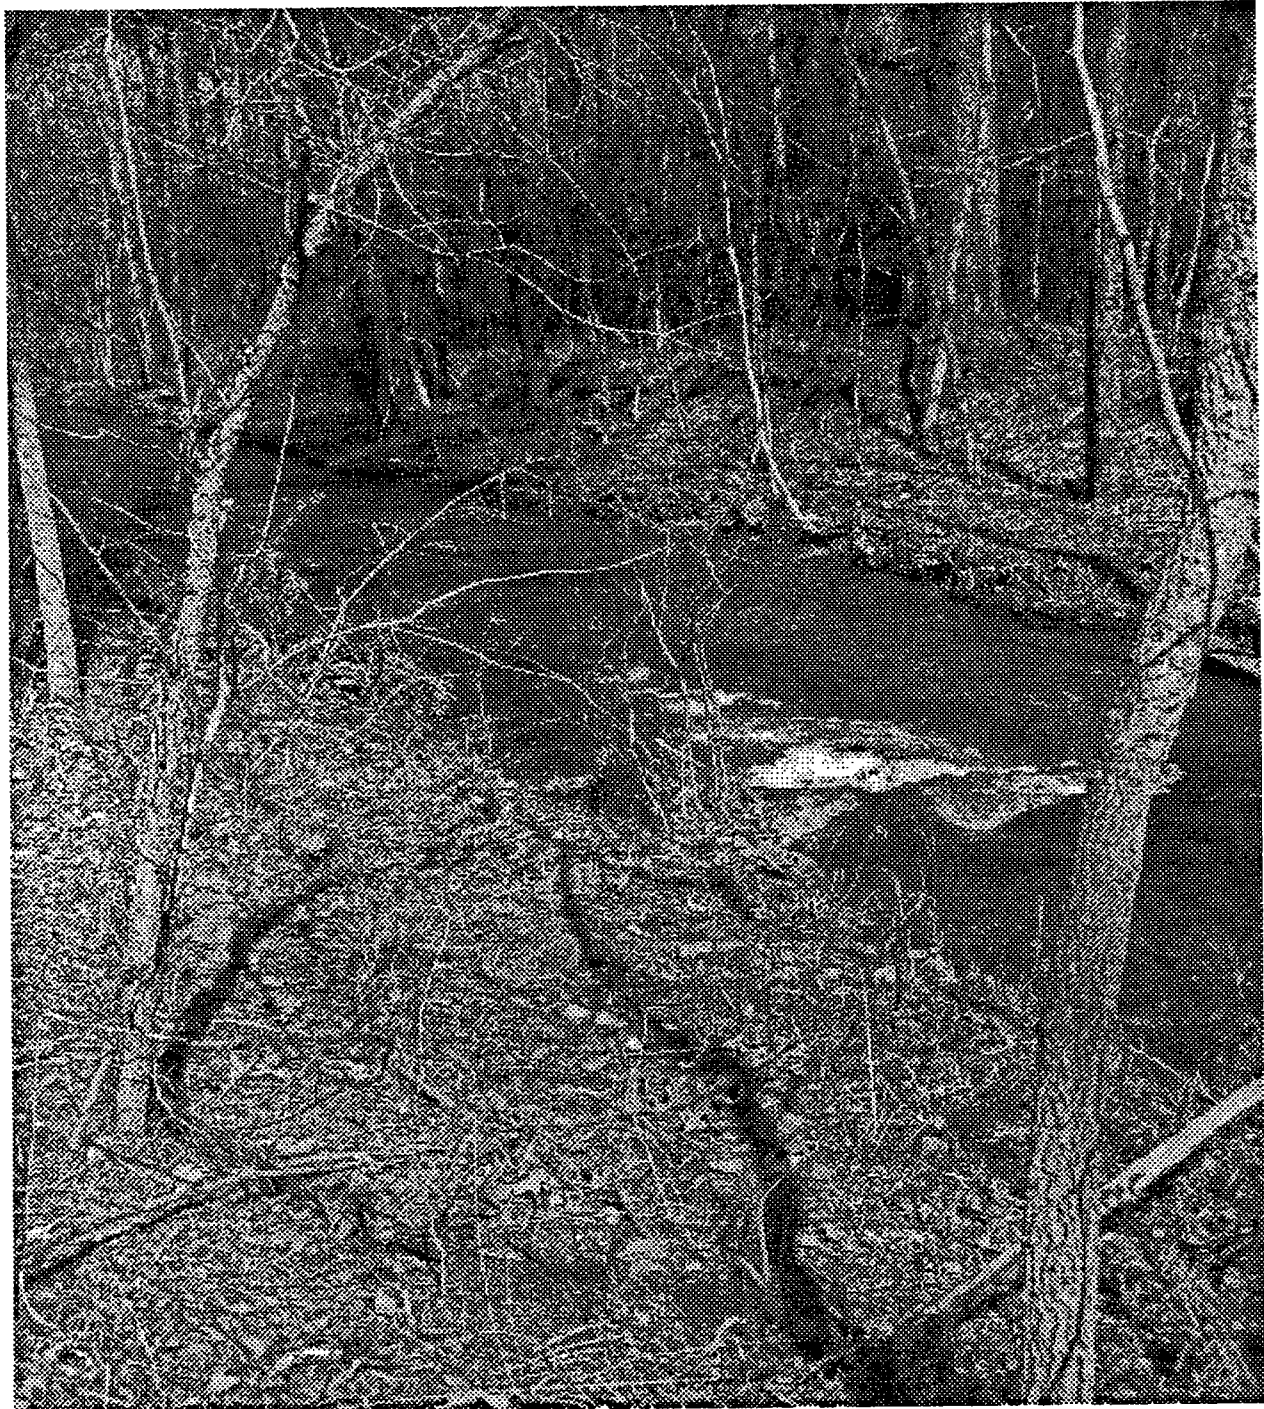
Photo A10 [3/3/98 - 11:05]

Former DPDO Area Building 1800 and current Autocraft Area [CERFA Parcel Map: 18,28-29]

Area contains sites 100(7), 20(7), and 47(7), and is nestled between the fork of South Branch Creek and an unnamed tributary to same; photo faces NW direction and includes the flood plain discharge location in the foreground adjacent to South Branch Creek.

The view is indicative of the general characteristic of creek bank in this reach (see also Photo A11). Tree are generally deciduous with very light to non-existent understory. Drainage ditch and discharge pipes are approximately 100 yards out of view to the left of viewer (see Photo A9).

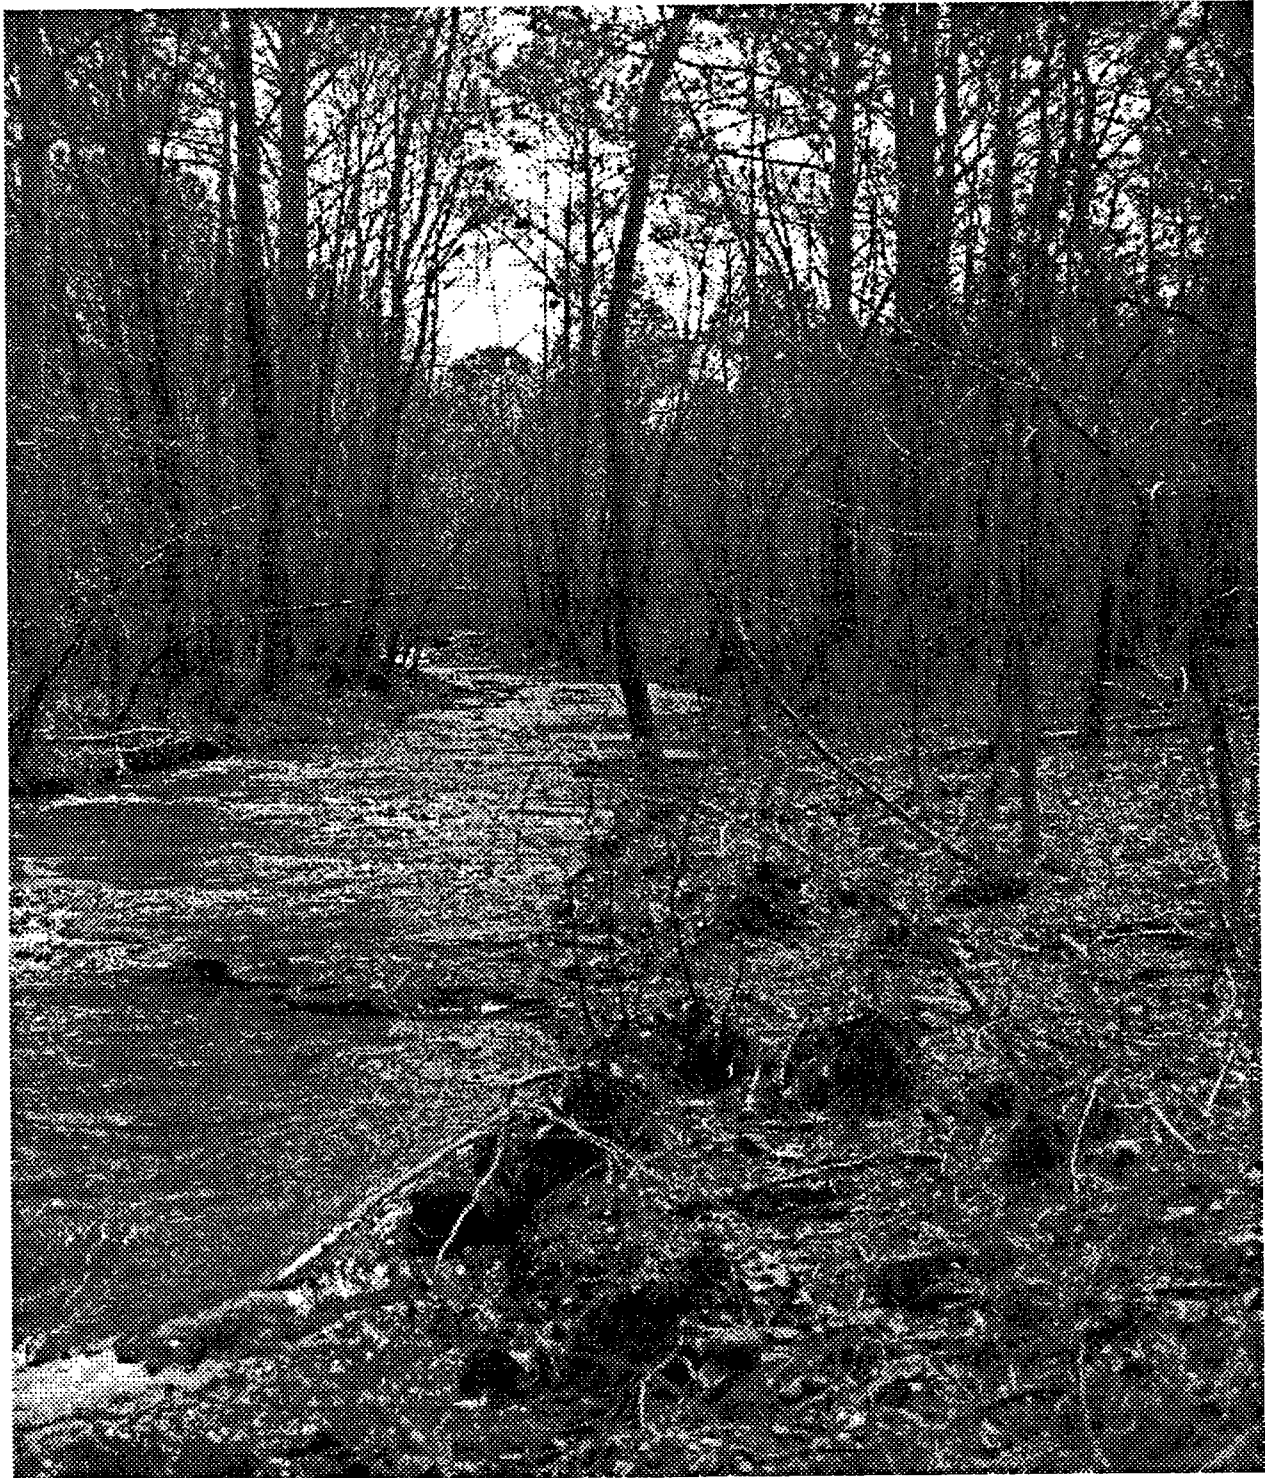
Photo A11 [3/3/98 - 11:05]

Former DPDO Area Building 1800 and current Autocraft Area [CERFA Parcel Map: 18,28-29]

Area contains sites 100(7), 20(7), and 47(7), and is nestled between the fork of South Branch Creek and an unnamed tributary to same; photo faces SE direction (upstream) at same location as Photo A10.

The view is indicative of the general characteristic of creek bank in this reach (see also Photo A11). Tree are generally deciduous with very light to non-existent understory. Drainage ditch and discharge pipes are approximately 100 yards out of view to the right of the viewer (see Photo A9).
